(Final Report, Revised February 25, 2016)
**Condition Assessment
&
Reserve Fund Plan Update
2016
GREENWAY FARMS**

Leesburg, Virginia

RE: **CONDITION ASSESSMENT AND RESERVE FUND PLAN UPDATE 2016**
Greenway Farms Homeowners Association
(Final Report, Revised February 25, 2016)
Leesburg, Virginia
Project No. 8011

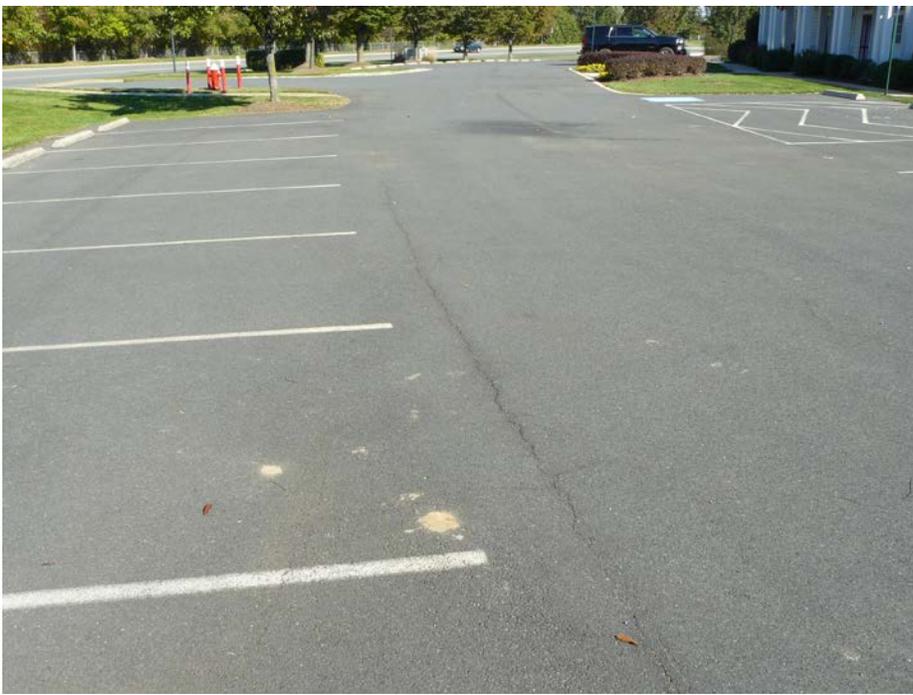
PHOTO #1
The asphalt drivelane and parking bays at the community center are in continuing good condition. Pavement maintenance such as full-depth repairs, crack filling, and seal coating should continue every six years.

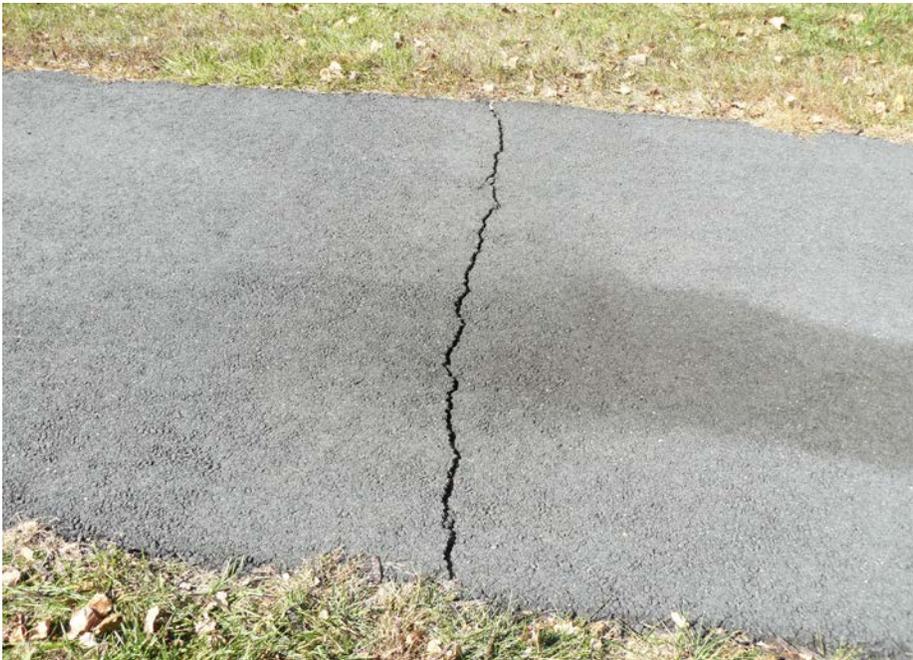
PHOTO #2
A majority of the asphalt footpaths are in good to excellent condition. Some transverse cracking was observed.

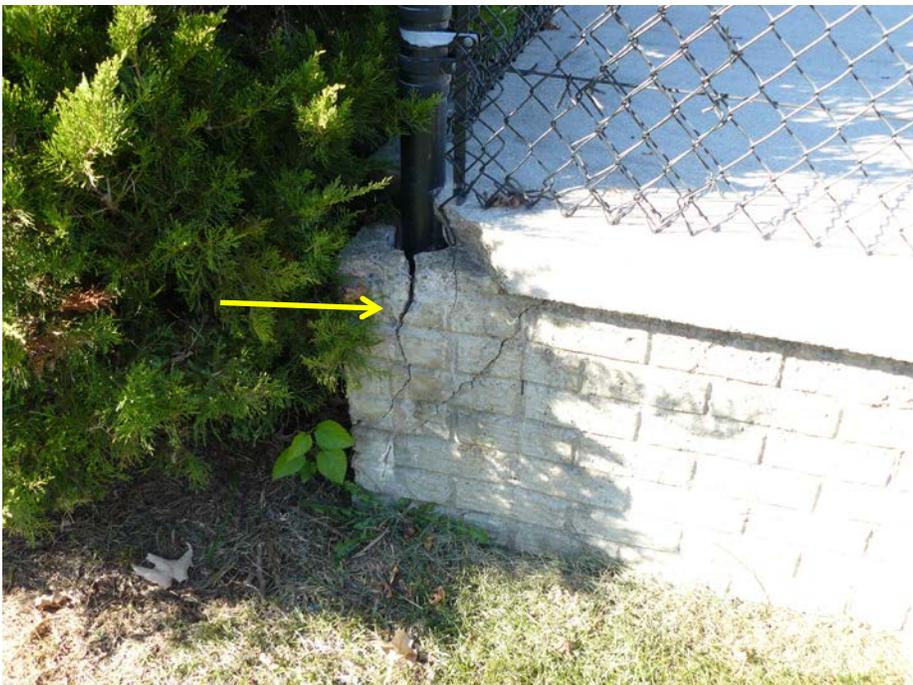
PHOTO #3
Cracking of the retaining wall at the pool, which helps to support the pool fencing continues to require repair.

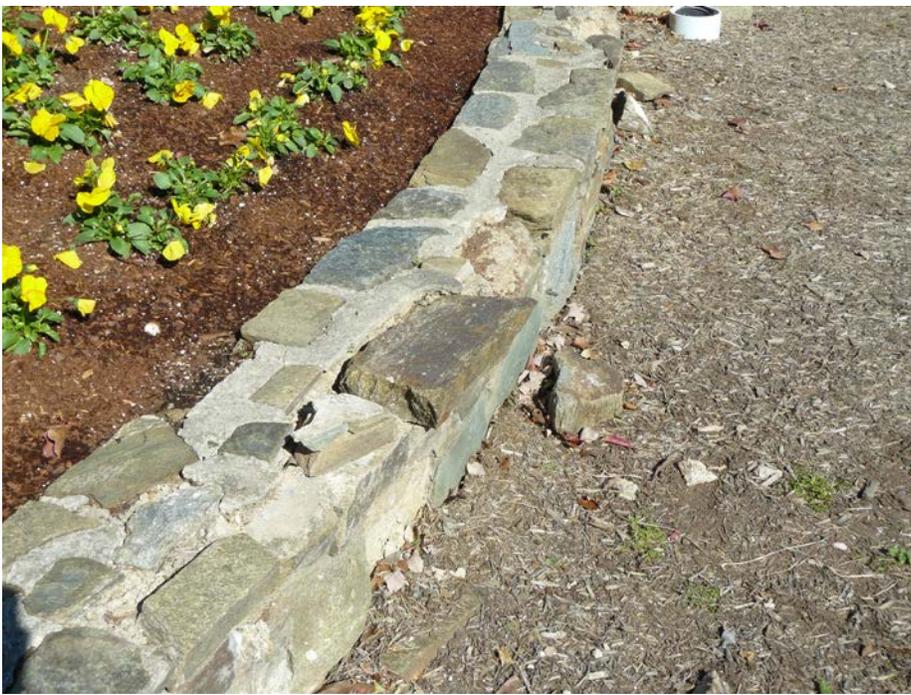
PHOTO #4
Significant deterioration of both entrance monument walls were observed, requiring repair.

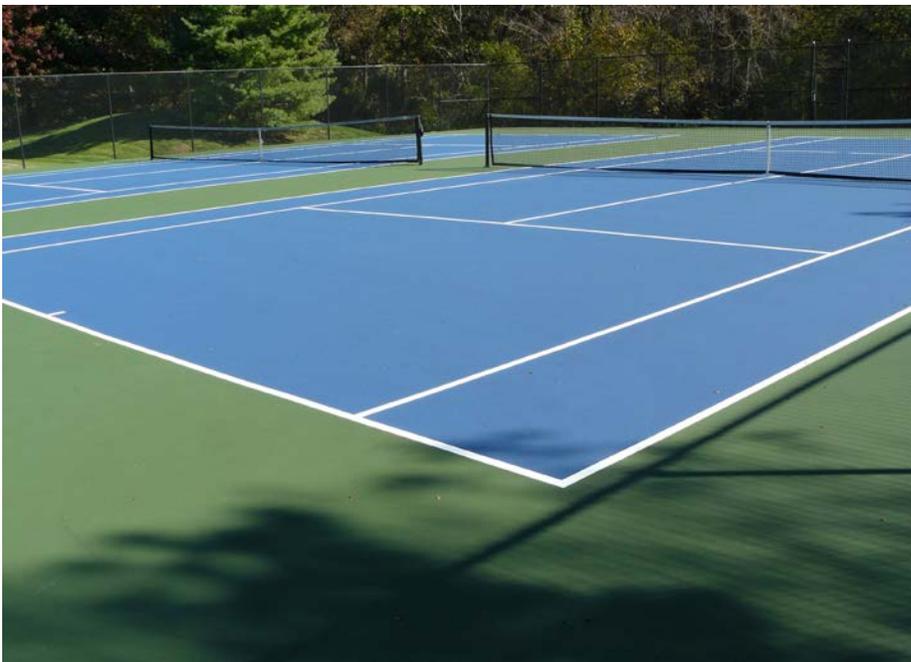
PHOTO #5
The tennis courts and the multipurpose court are in continuing good condition.

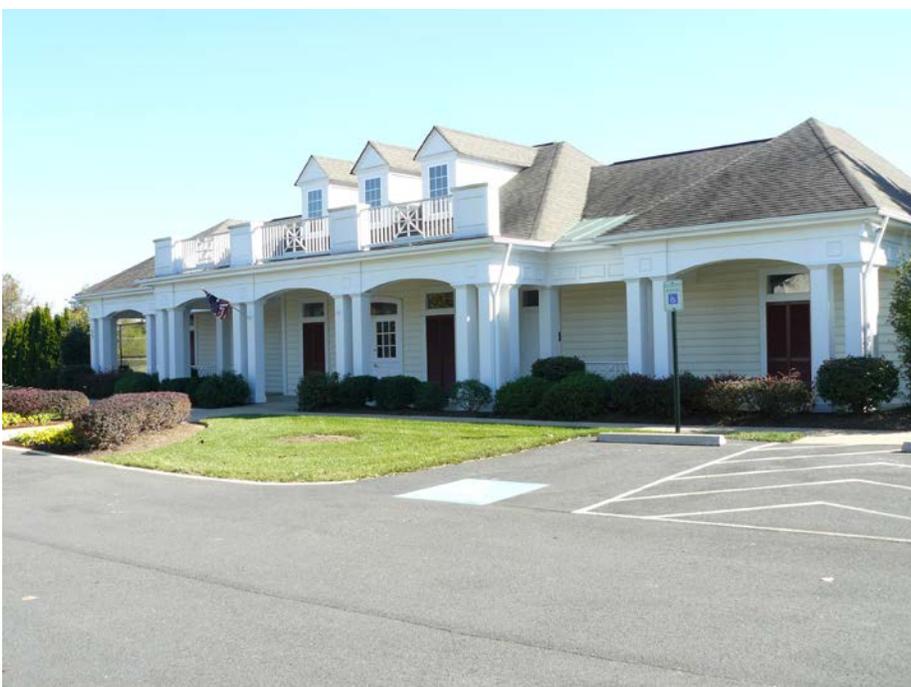
PHOTO #6
We understand that the roofing and facade railing of the community center building will be replaced near-term.

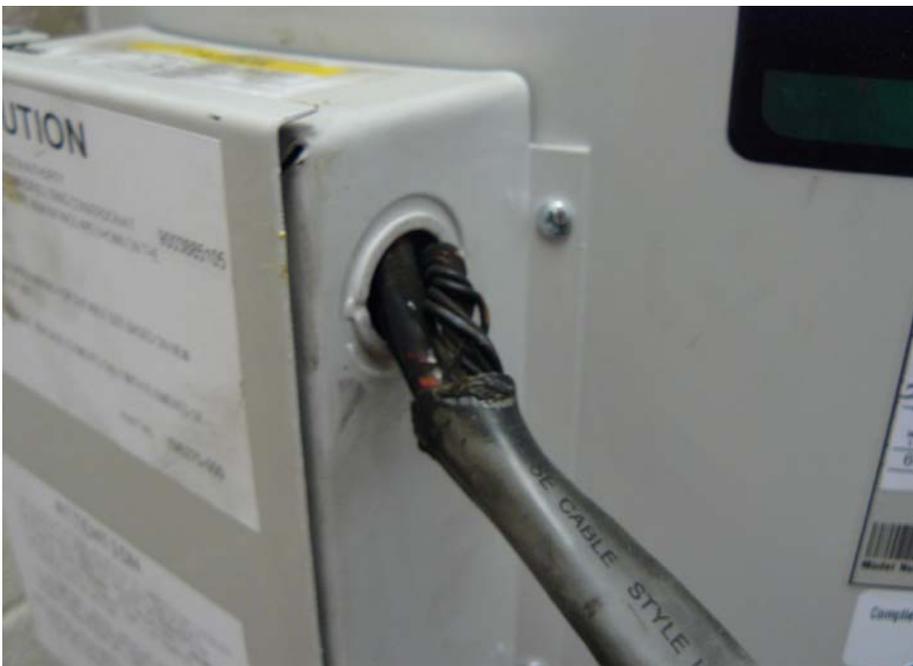
PHOTO #7
We are concerned with the heat damaged service wire, which was reused during the latest water heater replacement project. The wiring should be replaced.

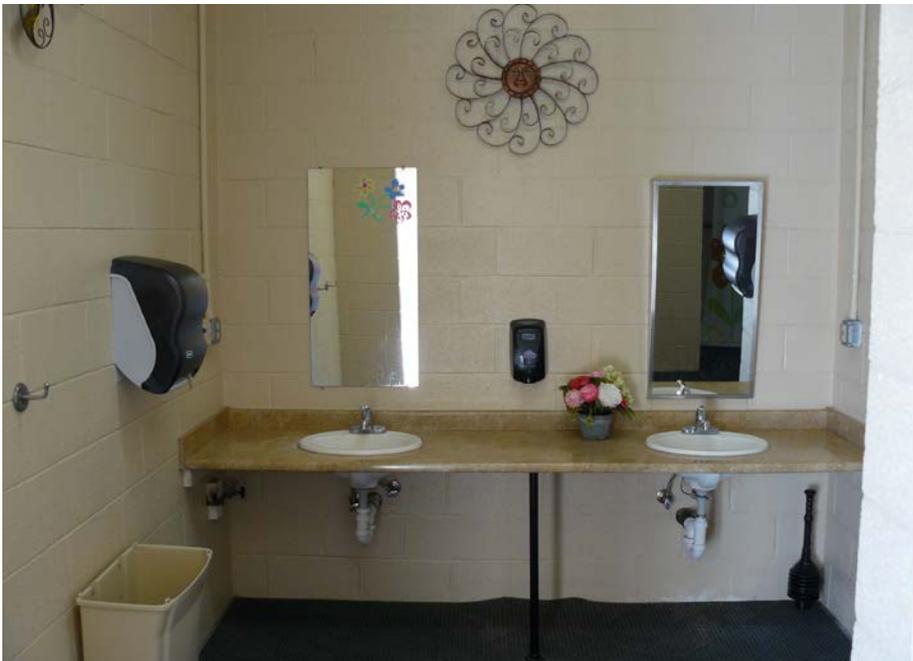
PHOTO #8
The plumbing fixtures, lighting, and electrical throughout the community center is in continuing good condition. The partitions of the bathhouses should be repainted.

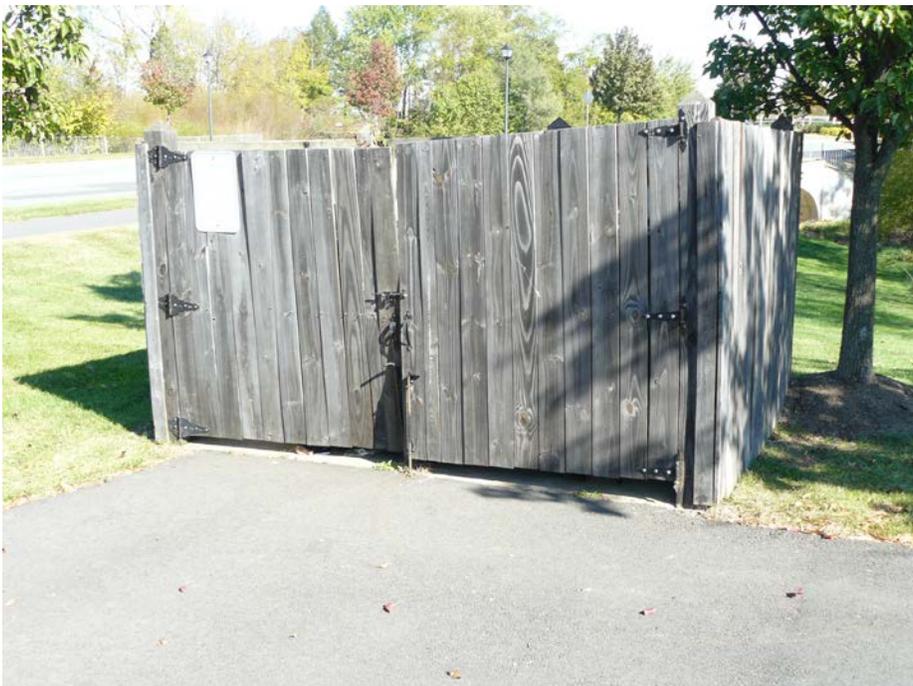
PHOTO #9
The dumpster fencing is nearing the end of its service life, requiring near-term replacement.

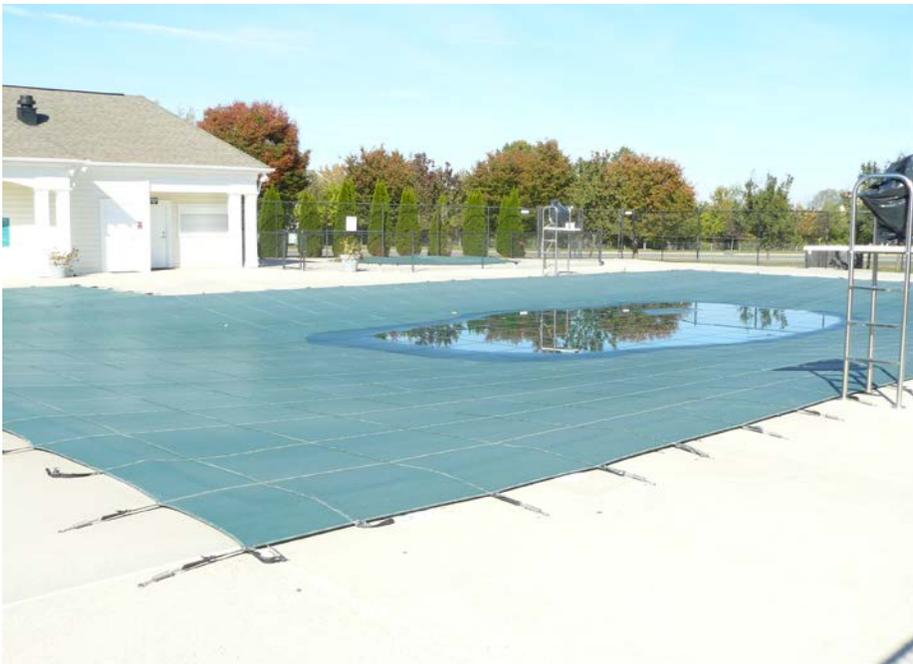
PHOTO #10

No problems were reported with either pool. The pool covers and pool perimeter equipment appear to be in fair to continuing good condition. Note: We were not able to evaluate either pool shell or white coat.

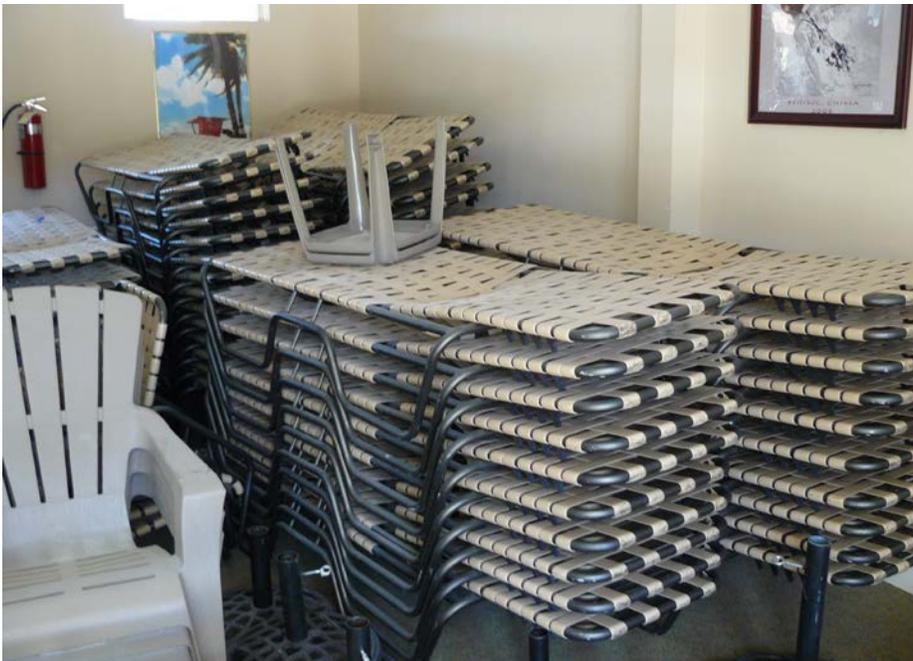
PHOTO #11

The pool furniture was recently replaced, including the outdoor tables. All equipment appears to be in continuing good condition.

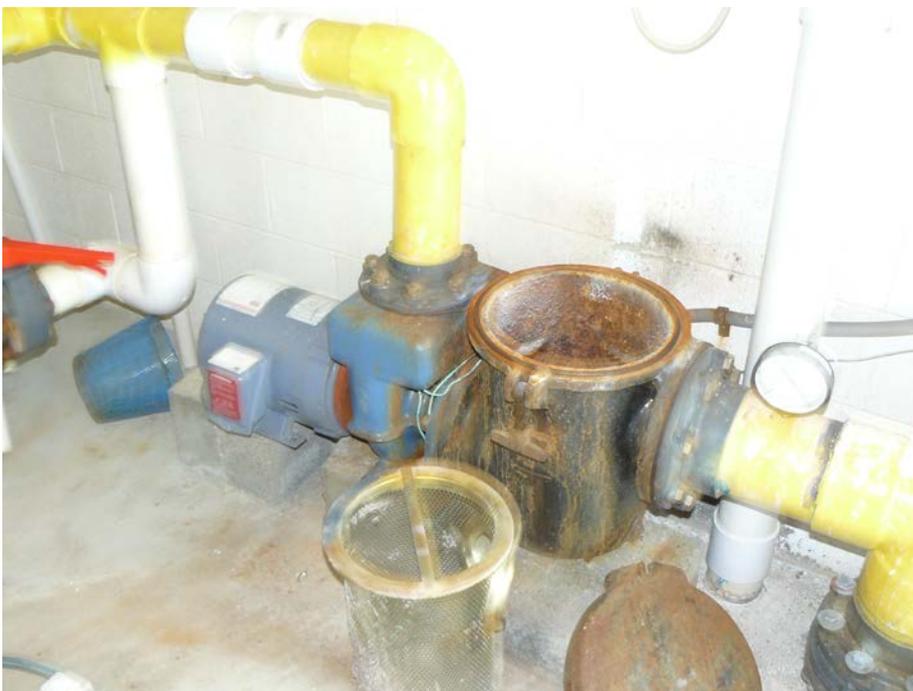
PHOTO #12

The main pool pump, metal strainer assembly, and the phase converter have been in service for several years, but appear to be in continuing serviceable condition.

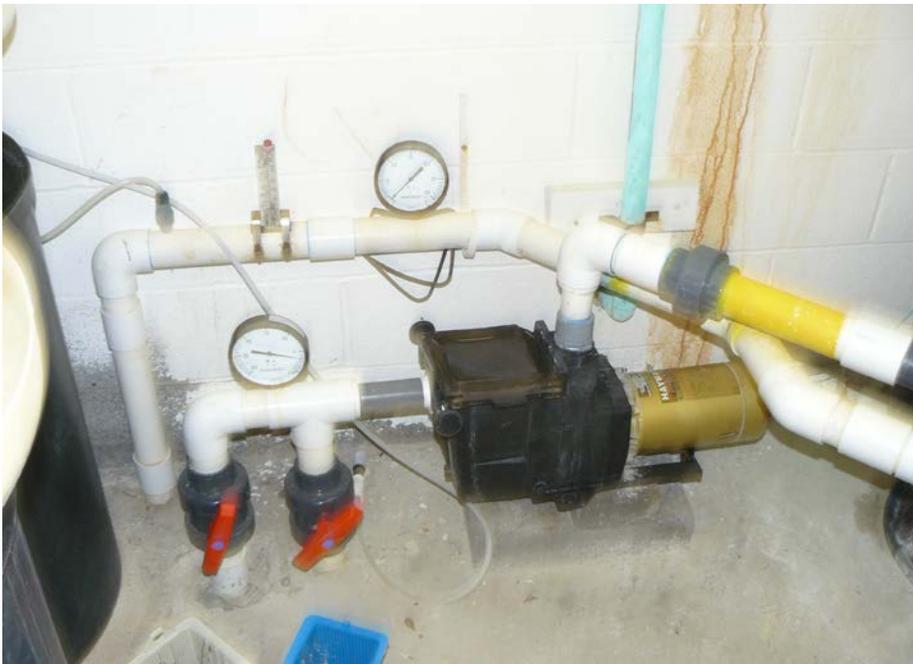
PHOTO #13

The wading pool pump and filter have also been in service for several years, and appear to be nearing the end of their service lives.

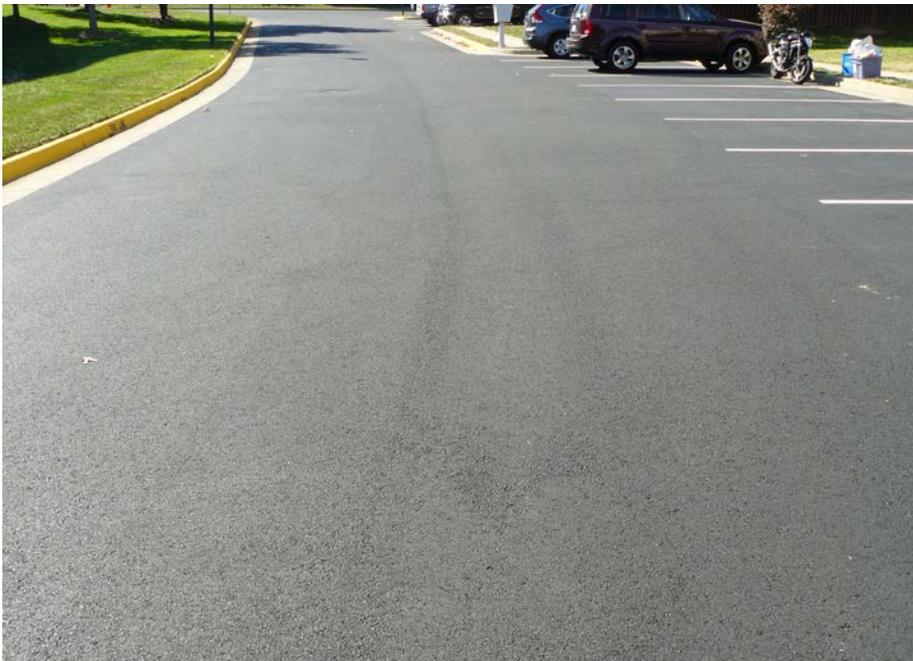
PHOTO #14

The townhome asphalt streets and parking bays, along with the street signage were recently restored and now appear to be in like new condition.

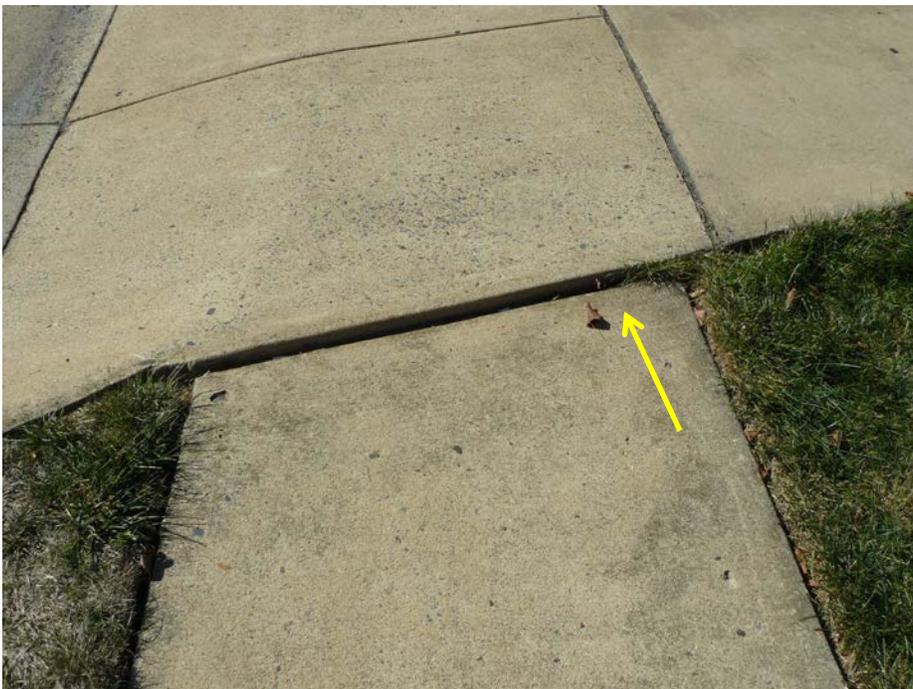
PHOTO #15

There is a minor quantity of cracked, settled and/or heaved concrete sidewalks at the townhomes, which are potential tripping hazards. The liability and costs associated with personal injury lawsuits resulting primarily from sidewalk and curb tripping hazards are too great to defer repair. It is our opinion that addressing deficiencies, which pose a hazard to pedestrians, should not be deferred. As such, we recommend correcting the tripping hazards observed throughout the sidewalks as soon as practicable.

Several concrete sidewalk panels have settled at some driveway aprons at the townhomes, requiring near-term repair/replacement.

6.6 Concrete Sidewalks: When sidewalks are cracked or scaled or sections have settled, the resulting differential or "tripping hazard" can present a liability problem for the Association if personal injury should occur as a result. Tripping hazards should be repaired expeditiously to promote safety and prevent liability problems for the community. Generally, where practical and appropriate, concrete element repairs and replacements are scheduled in the same years to promote cost efficiencies. Replacements are usually scheduled in cycles because the necessity of full replacement at one time is unlikely. Typically, damaged or differentially settled sections can be removed by saw cutting or jack hammer and re-cast. Concrete milling of the differential surfaces is sometimes an appropriate, cost-effective alternative to re-casting. Skim coating is not an effective repair for scaled or settled concrete surfaces and, over time, will usually worsen the problem.
