Condition Assessment
&
Reserve Fund Plan Update
2021

GREENWAY FARMS

Leesburg, Virginia

RE: **CONDITION ASSESSMENT AND RESERVE FUND PLAN UPDATE 2021**
Greenway Farms Homeowners Association
(Final Report, August 19, 2021)
Leesburg, Virginia
Project No. 9188

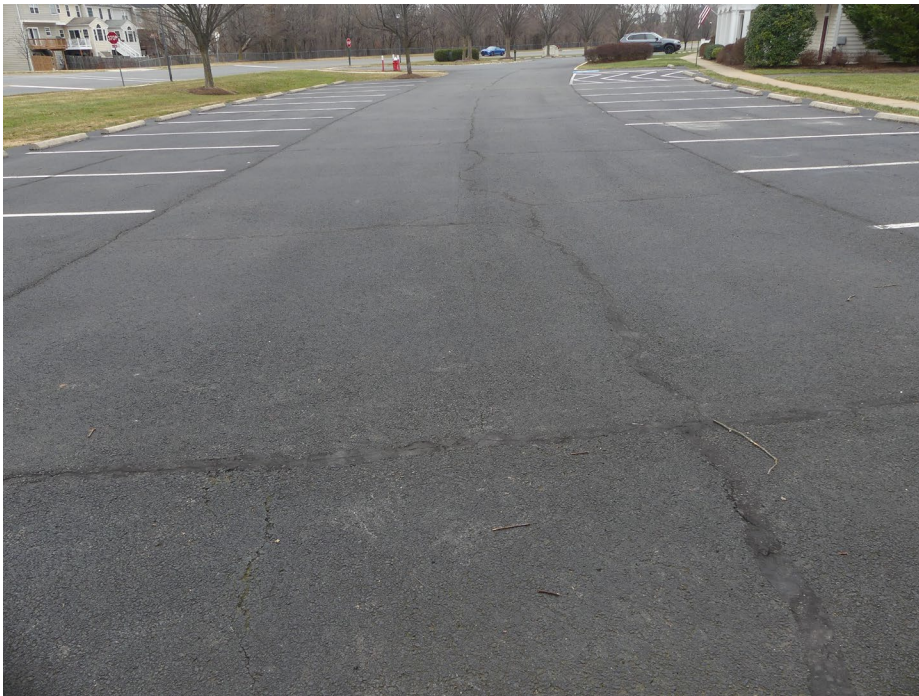
PHOTO #1
The asphalt parking area at the pool is in continuing good condition. Crack filling and seal coating is scheduled and should be coordinated with the pavement maintenance of the townhome pavement.

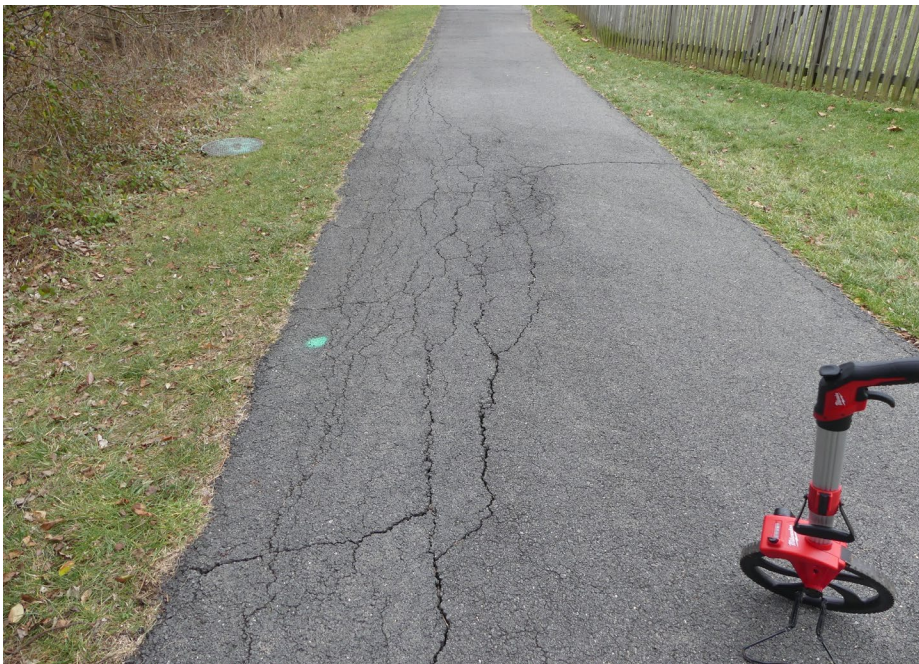
PHOTO #2
The asphalt footpaths range from fair to generally continuing good condition. A few areas of deflected pavement were observed, requiring repair.

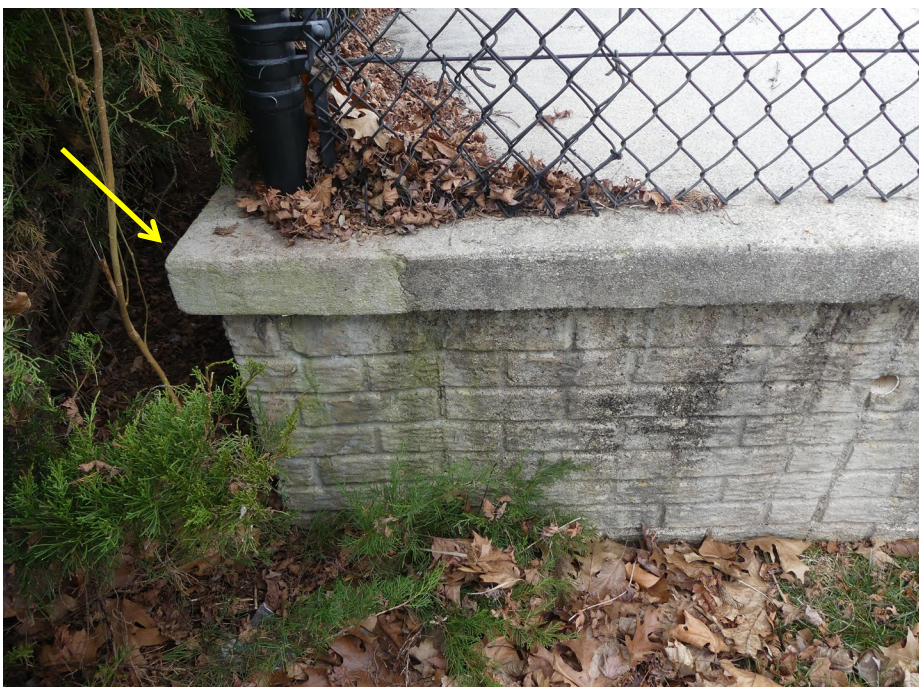
PHOTO #3
The concrete retaining wall that supports the pool deck was properly repaired since our previous evaluation and appears to be in continuing good condition.

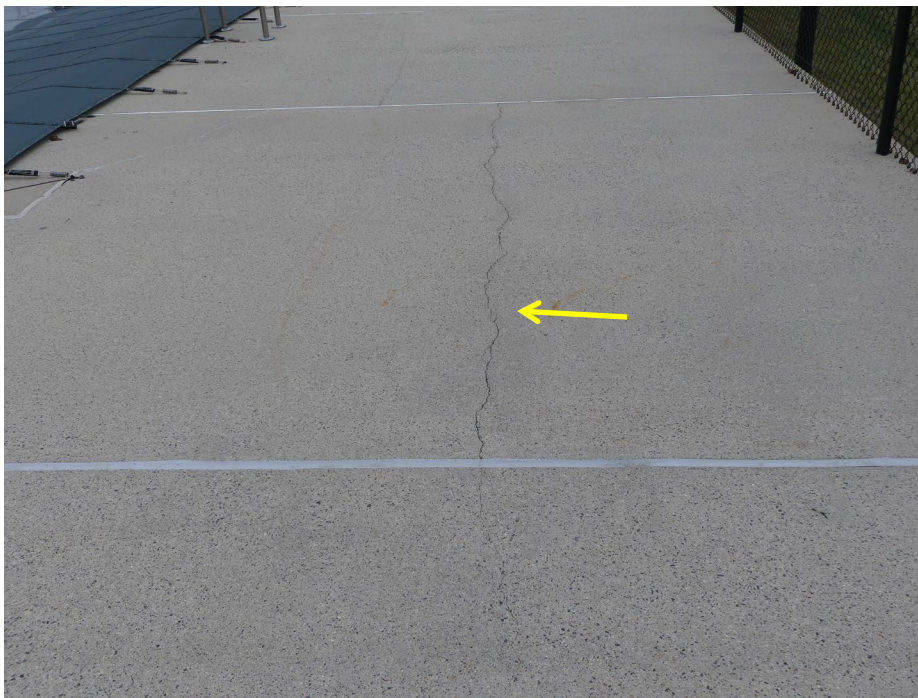
PHOTO #4

A minor amount of cracking was observed on the pool deck. These cracks should be routed and sealed to prevent water infiltration below the pool deck.

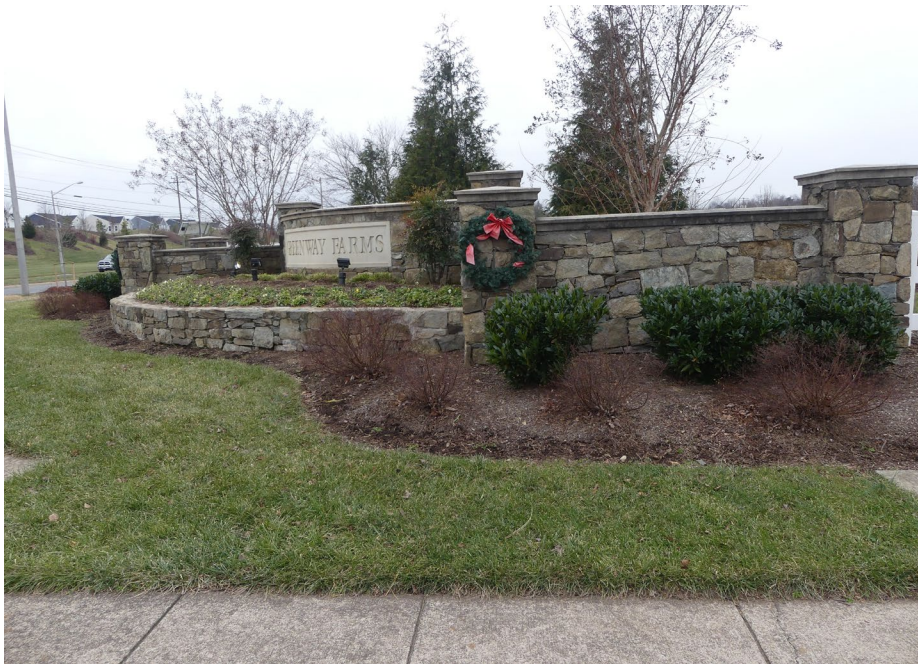
PHOTO #5

The entrance monument walls have been tuckpointed and repaired since our previous evaluation and appear to be in continuing good condition. Landscape lighting was not evaluated after dark, but appears to be in continuing good condition.

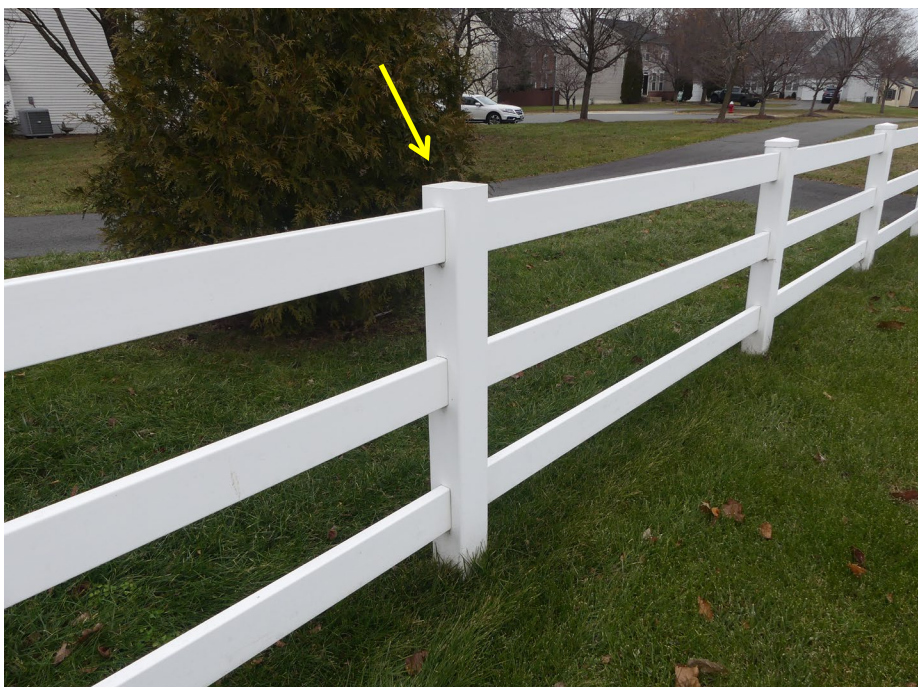
PHOTO #6

The vinyl fencing is in continuing good condition. Localized replacement of post caps or any other missing components of the fencing should be completed under operations. Eventual pressure washing to remove algae staining will help to improve appearance.

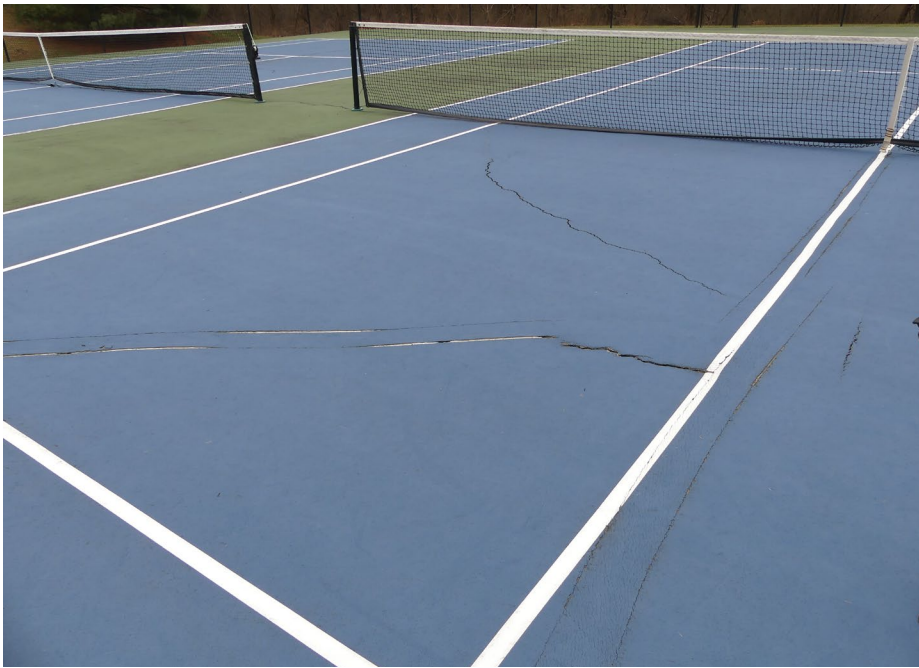
PHOTO #7
The tennis courts are exhibiting a moderate quantity of cracking. We understand that a contract is in place to repair and re-color coat the courts near-term.

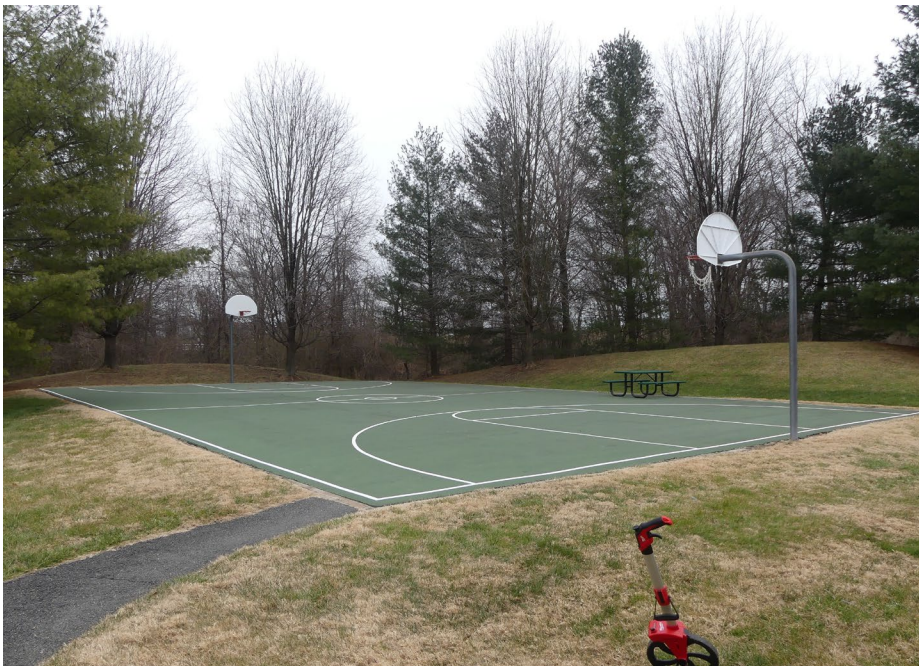
PHOTO #8
The multipurpose court and goals are in continuing good condition. The court cracking should also be repaired near-term.

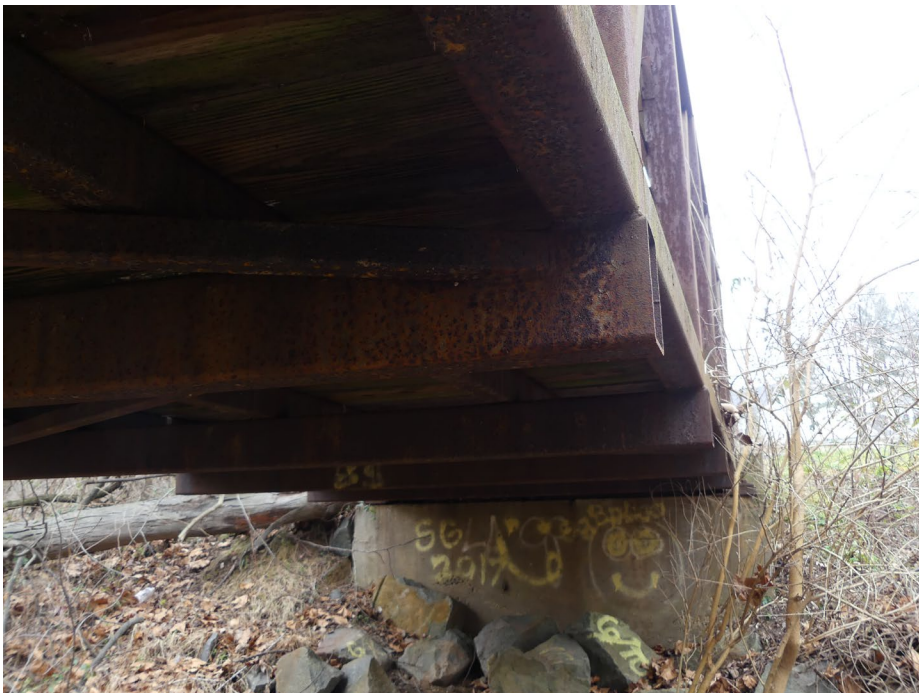
PHOTO #9
A significant quantity of rusting was observed on all metal surfaces of the footbridge. Cleaning, priming, and painting, while difficult, may help to maximize the bridge service life.

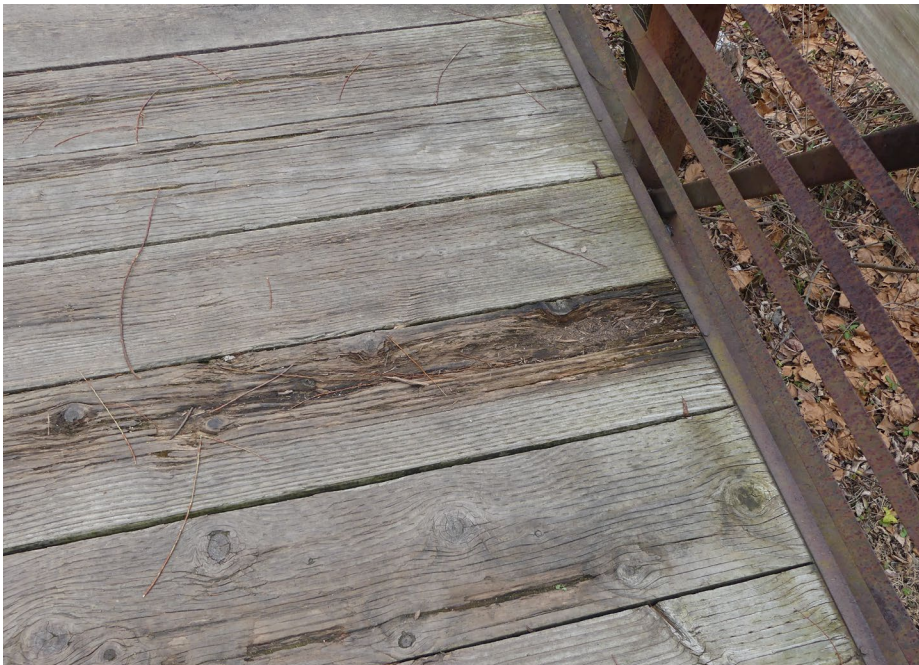
PHOTO #10

A few of the wood treads of the footbridge are beginning to rot, requiring localized replacement. Note the rusting rails.

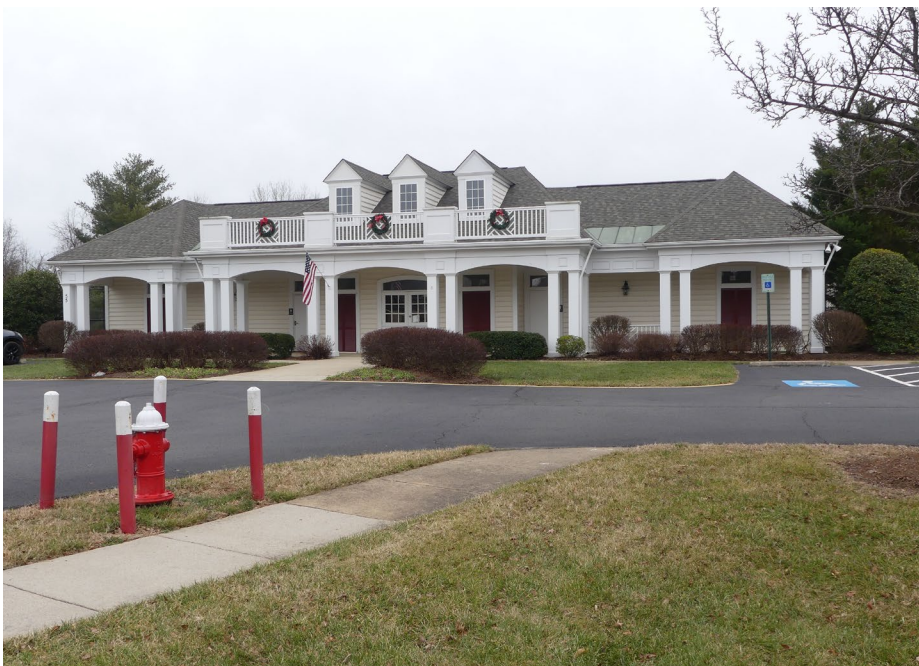
PHOTO #11

The community center roofing was replaced and appears to be in excellent condition. The vinyl siding, wood trim, windows, and most doors are in continuing good condition.

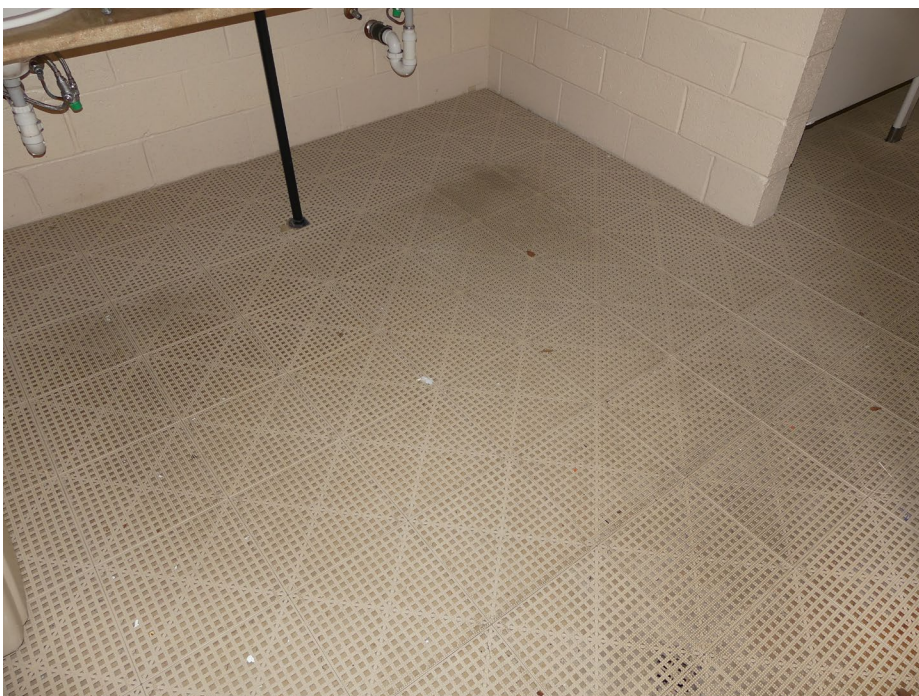
PHOTO #12

The dry deck flooring ranges from fair to continuing good condition. Some staining was observed. We have scheduled dry deck replacement in the next year or two.

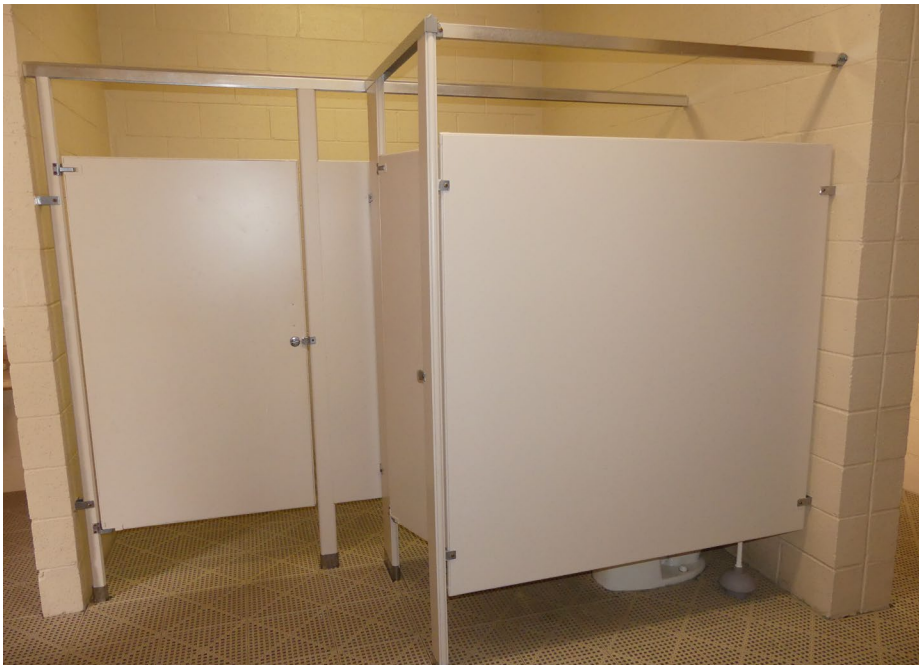
PHOTO #13
The plumbing components range from fair to continuing good condition. The partitions have been painted which will help to maximize their service life and improve appearance.

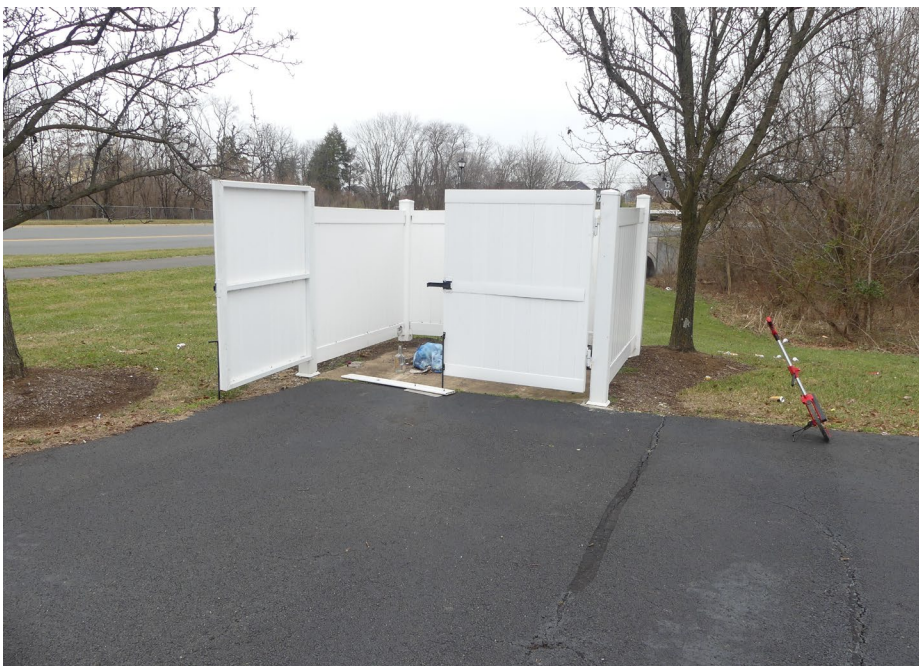
PHOTO #14
The wood dumpster enclosure was replaced with PVC fencing and gates and is now in good condition.

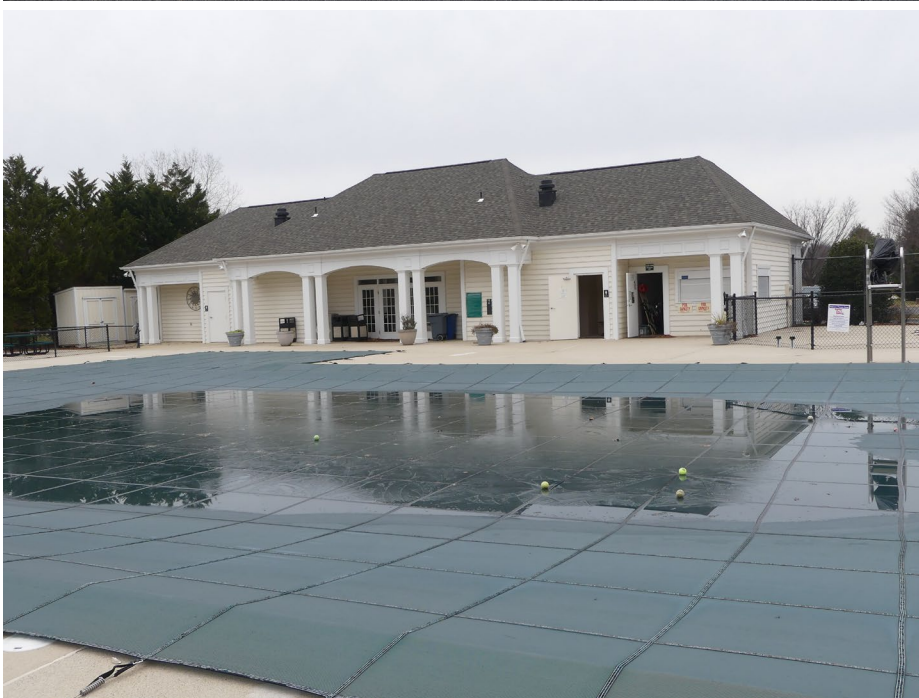
PHOTO #15
We understand that the pools were restored in 2018. They were covered for the season and could not be evaluated.

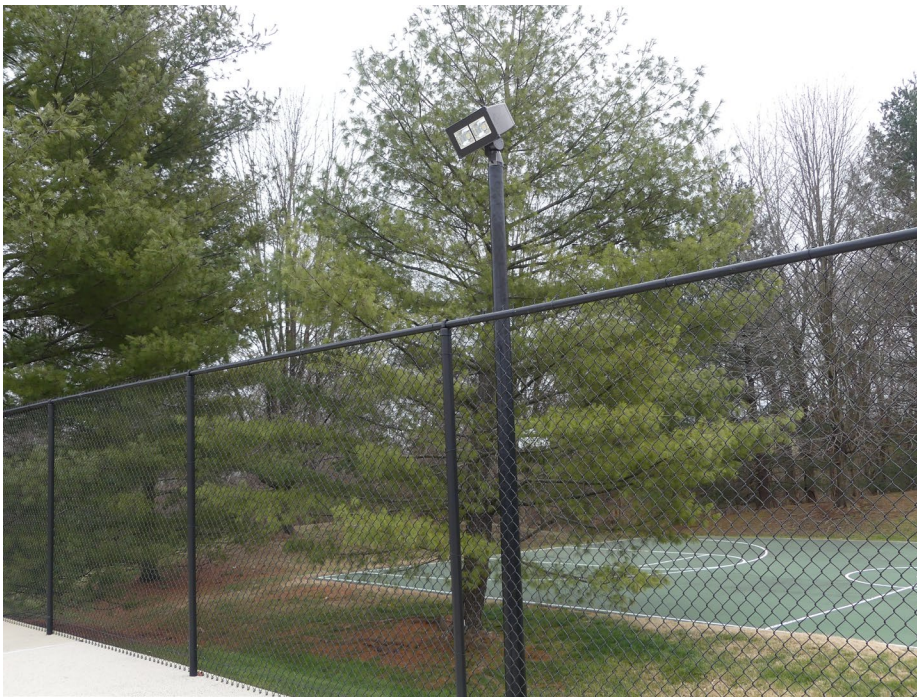
PHOTO #16
The fencing and light fixtures at the pool area appear to be in continuing good condition.

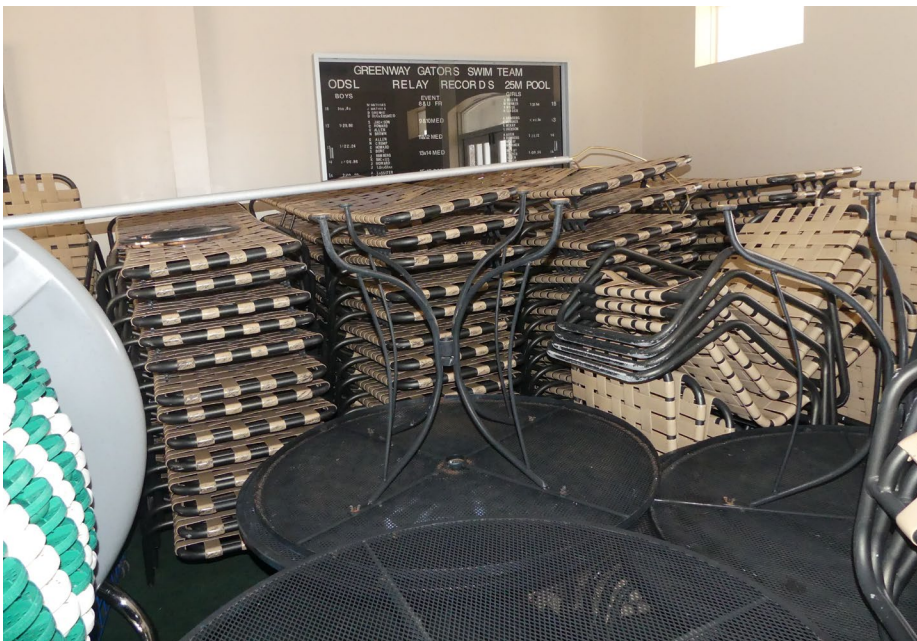
PHOTO #17
The pool furniture was stacked in the community center for the season. Management requested we include an allowance for near-term replacement.

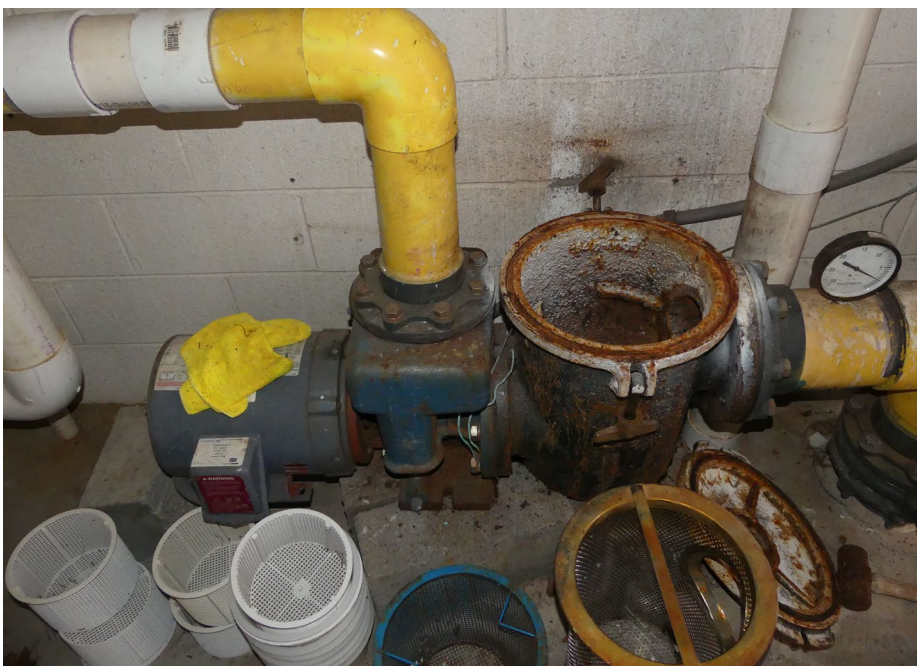
PHOTO #18
The pool pump and metal strainer may be nearing the end of their service life. The strainer was observed with significant rust.

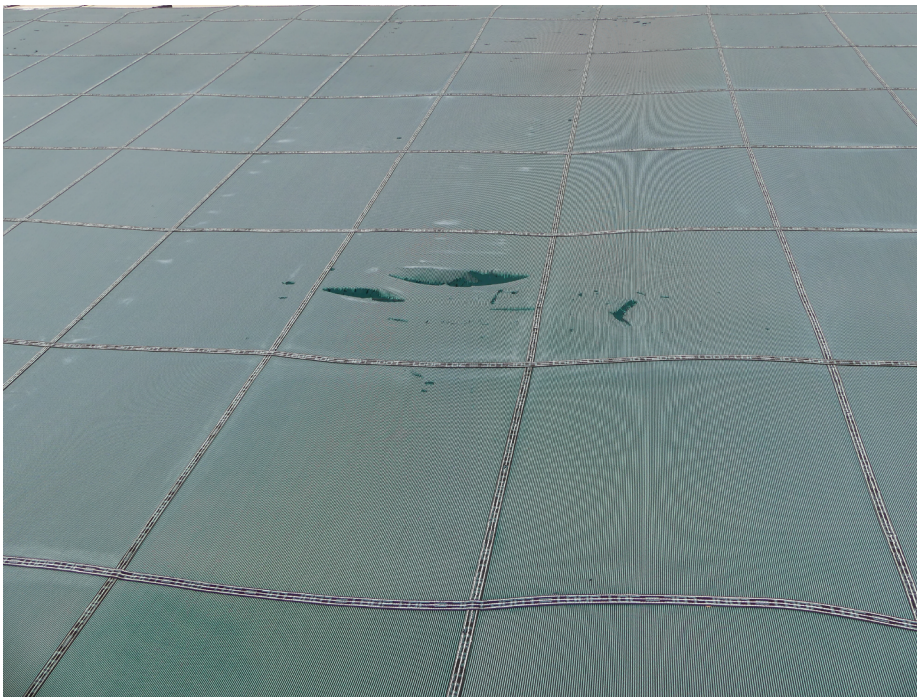
PHOTO #19

The pool covers are also nearing the end of their service life. We observed deteriorated fabric and some tears. The wading pool cover was also deflected. We have scheduled both for near-term replacement.

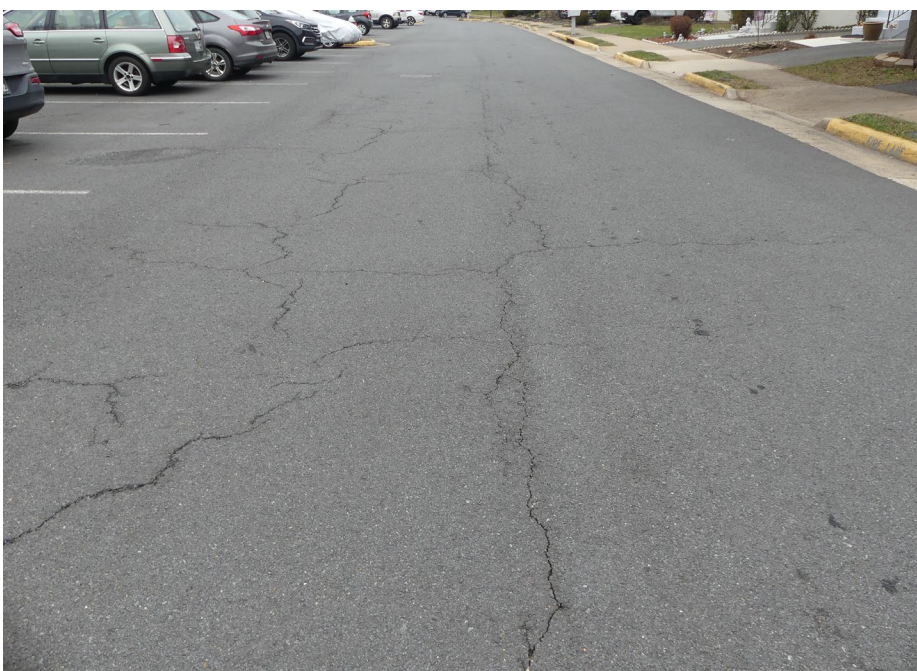
PHOTO #20

The townhome pavement ranges from fair to generally continuing good condition. We did not observe any major deflected asphalt (indicative of sub-base damage), and only moderate quantities of longitudinal and transverse cracking. Pavement maintenance, including crack filling and seal coating should be accomplished near-term. Concrete sidewalks, curbs and gutters, driveway aprons, and the street signage are in generally good condition.

The townhome asphalt pavement ranges from fair to good condition. We did not observe any major deflected asphalt. However, a moderate quantity of longitudinal and transverse cracking was observed. We have scheduled pavement maintenance (crack filling and seal coating) near-term.

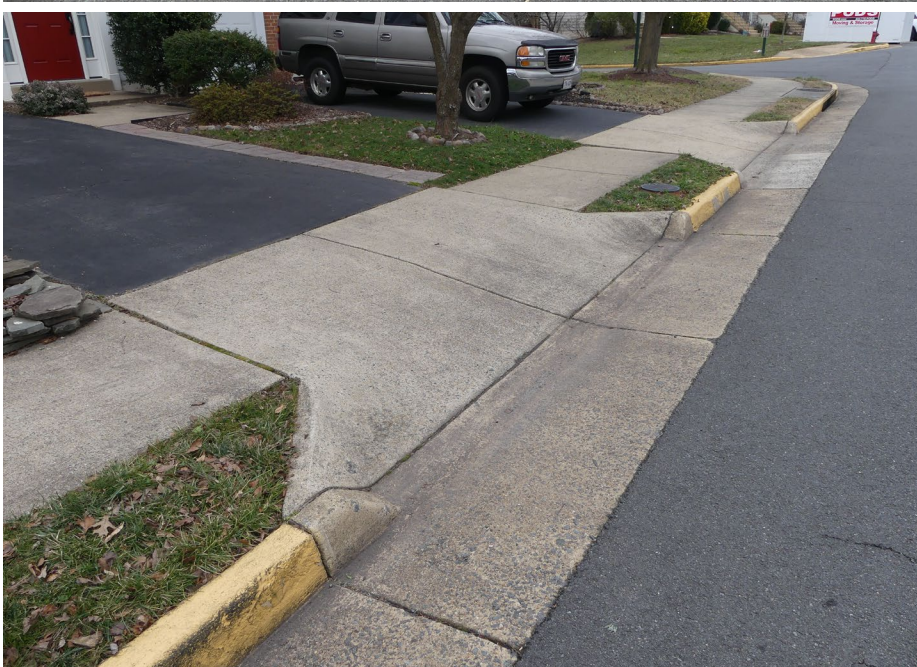
PHOTO #21

The concrete sidewalks, curbs and gutters, and the driveway aprons range from fair to generally continuing good condition.
